NISTIR 6619

Failure Analysis of the WWVB Tower

August 2002

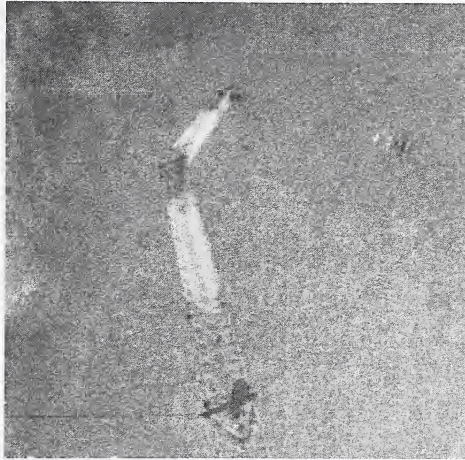
Figure 1: Photo shows results of failure of insulator pin. Upper portion of tower had to be replaced and new pins replaced.

The failure resulted in a collapse of the uppermost 30 m of the 122 m tower as shown in figure 1. The tower, originally constructed in 1962, was refurbished in late 1999 when new pins replaced the old pins. The new pins had been in service approximately 2 to 3 years when failure occurred. The old pins had been in service approximately 37 years with no failures. The pins were connected to guy wires supporting the towers, via Lapp* insulators, and anchored to concrete bases via clevis-pin attachments (figs. 2 and 3).

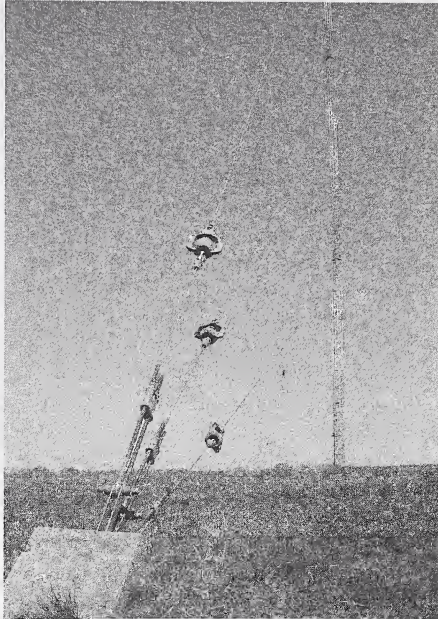
Figure 2: Photo shows guy wires, Lapp insulators with pins, and concrete anchors.

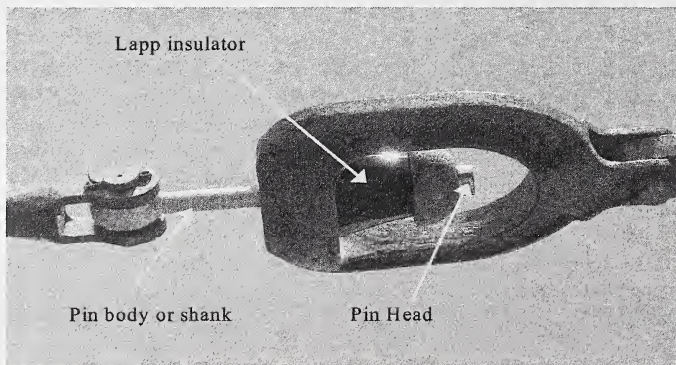
Figure 3: Close-up of Lapp insulator and pin arrangement.

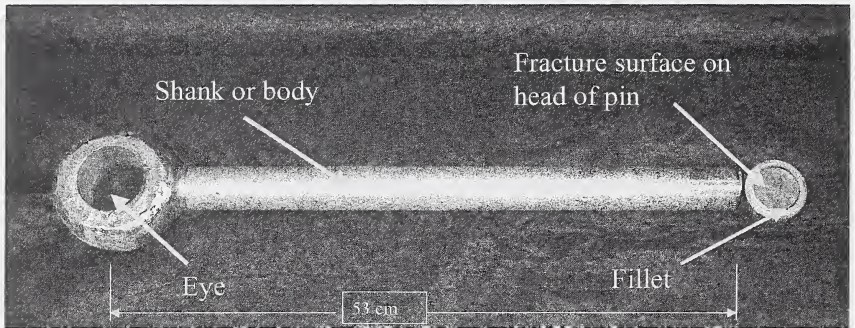
The new pin failed in the radius of the shank-to-head fillet, as shown in figures 4 and 5. Visual examination of the fracture surfaces indicated failure was initiated by fatigue. The fatigue crack grew until the remaining ligament had insufficient area to support the loads imposed on the pin. Numerous small pits on the surface, as well as some circumferential tool marks covered the surface along the shank of the pin and some regions of the radius area. The fact that the pins were made from 50 mm diameter stock brings into mind the question of the origin of the many pits found on the surface of the shank and fillet of the pin. It is unlikely that the pits and other surface defects were part of the original surface of the stock. It is more likely these flaws occurred during the fabrication of the pins.

Figure 4: The new pin with failure in the radius of the shank-to-head fillet. The fracture surface can be seen on the head at the right end of the photo.

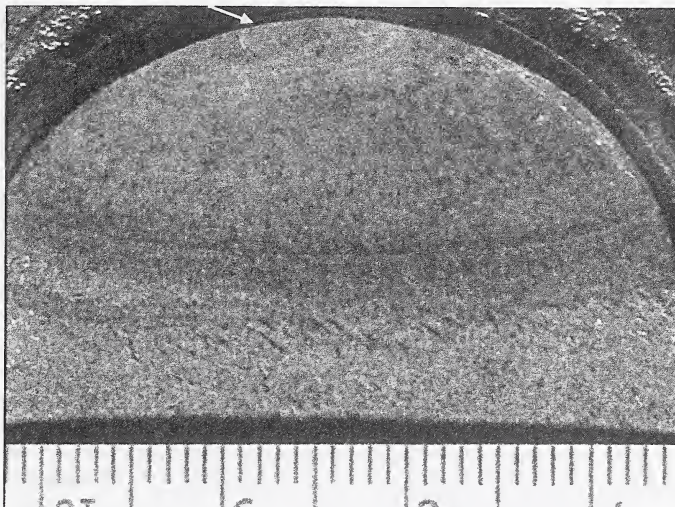
The pin failed because a fatigue crack initiated at the radius machined under the head of the pin, and this crack grew until the cross-sectional area of the pin was decreased to an area that was too small to carry the applied tensile load. As shown in figure 6, beach marks are present on the fracture surface. The presence of beach marks identifies this as a fatigue failure [3]. The beach marks can occur as a result of changes in loading, environmental effects, and other factors that influence the crack growth and/or appearance of the surfaces of the crack faces.

The beach marks are centered about the origin of the crack, indicating that the crack that caused this failure initiated in the region marked by the arrow. The rougher surface appearance in the lower portion of the figure is the final fracture region. Final fracture, or overload fracture, occurred when the cross-sectional area of the pin was reduced by fatigue cracking to an area no longer sufficient to carry the applied load. Once the critical stress was reached, the pin failed by rapid, catastrophic fracture.

Figure 6: Fractured surface of the insulator pin. The arrow points to the fatigue crack origin. The scale at the bottom of the figure is in millimeters.

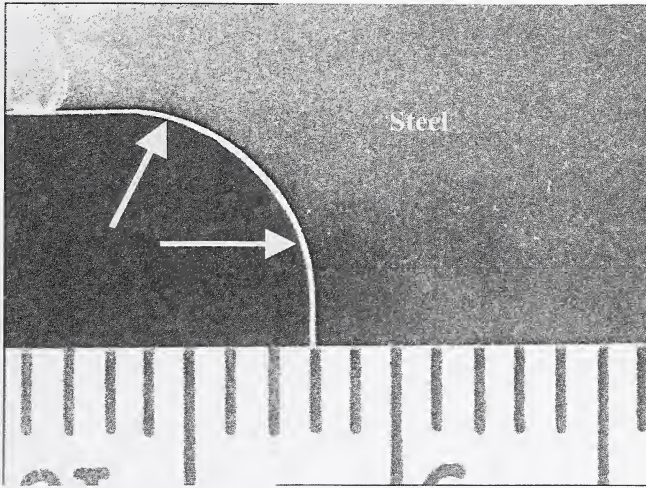
Figure 7: The “old” pins had a large (4.76 mm) radius, helpful in avoiding a high stress concentration at the change in cross-sectional area associated with the shank-to-head transition. The scale is in millimeters.

To determine the fatigue stress-concentration factor, K_f , in the old AISI 1030 carbon steel pin with a 4.8 mm (0.1875 in) radius in the cross-sectional change between the head and body, we must first find the static stress-concentration factor K_t and the notch sensitivity factor q . The diameters of the head and body are, respectively, 54.7 mm (2.155 in) and 38.1 mm (1.5 in). Substituting known variables in (2), (4) and (5) above, we obtain a K_f of 1.73.

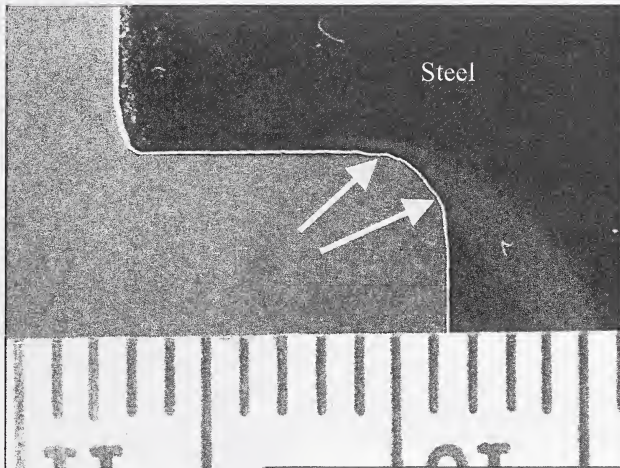
Figure 8: The “new” pins had a smaller (1.9 to 2.9 mm) radius at the shank-to-head transition, clearly increasing the stress concentration associated with this transition. The scale is in millimeters.

where d is the body diameter, r is the radius at the transition, and the coefficient A and the exponent b are found in the table in Figure C.1. Knowing the geometry of the axially loaded pin, we can use the figure in Figure C.1 to determine the theoretical stress-concentration factor. The stress-concentration factor at the radius for the AISI 1030 pin with a radius of 4.8 mm (0.1875 in) is found to be 1.73, and the stress-concentration factor for the AISI 4140 steel with a radius of only 1.9 mm (0.07 in) is 2.29, 32% higher than a stress of 1.73.

Using the same equations, we calculate K_f for the new AISI 4140 alloy steel pins with respective head and body diameters of 55.4 mm (2.18 in) and 38.1 mm (1.5 in), and radii that varied from 1.9 mm (0.07 in) to 2.9 mm (0.11 in). The less severe radius was the 2.9 mm radius with a K_f of 2.05. The sharper radius, measured at 1.9 mm (0.07 in), had a K_f of 2.13.

New pins should be fabricated from proper drawings calling out dimensional tolerances, surface finishes, a generous radius in the fillet (within limits specified for the specific insulator washer), appropriate heat-treatment to optimize properties for toughness and fatigue strength, and a plating process that does not degrade the surface or integrity of the pins. If new pins are forged from AISI 4140, before being machined, the pins should be normalized, hardened, and tempered to between 28 and 32 HRC to increase fatigue strength. The microstructure should be 100 % tempered martensite and the prior austenite grain size should be reasonable. In order to minimize the chance of hydrogen embrittlement and pitting, we recommend that the pins not be pickled prior to plating. However, pickling may be used if appropriate guidelines, such as those recommended in ASTM A143-01 [6], are closely followed.

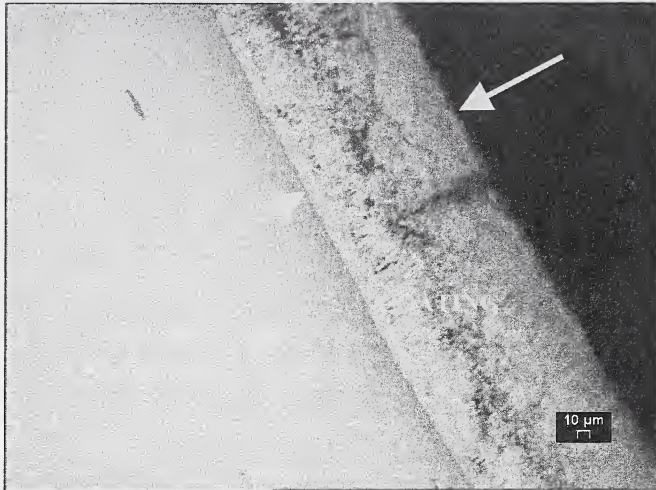
Figure 9: The coating layer on the old pins was approximately 100 μm thick. This coating is typical of those found for steel that has been hot-dip galvanized.

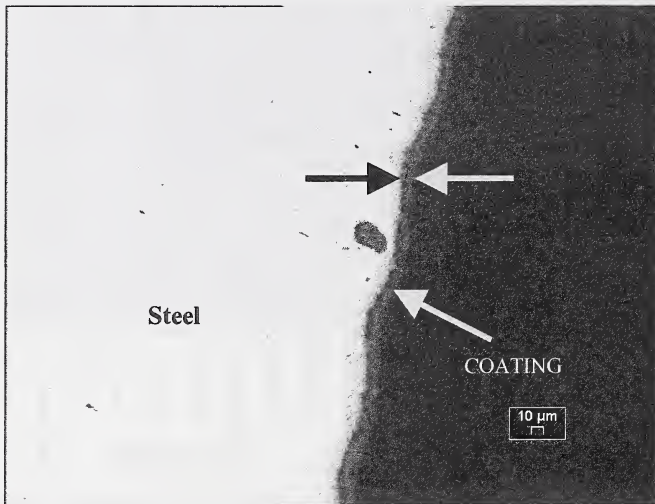
Differences in the type and quantity of surface flaws were observed on the new and old pins. As shown in figures 9 and 10, the surface of the steel used for the old pins is relatively planar and free of defects, compared with the surface typical of the new pins. The old pins have a hot-dip galvanized coating that is about 100 μm thick and the new pins have a 10 μm thick electroplated zinc coating. Also note in figure 10 that the interface between the steel and the

coating is wavy and irregular on the new pin, much different from that seen in the previous figure of the old pin. The new pins had numerous pits on the surface, along the shank as well as in the radius. In figure 11, three pits on the surface of the N2 sample are shown in the cross-section. These pits are near the radius at the head of the pin. We estimate the radius of these pits to be about 100 μm , so they clearly provide high local stress-concentrations. The surface pitting may be the result of improper pickling prior to electroplating or other steps involved in removing the original zinc coating. The pits in the AISI 4140 steel pins occurred sometime between the time they were forged and machined from 50 mm stock and the second time they were electroplated, because the Zn coating is present on the outside surface of the flaws.

Figure 10: The new pins have a 10 μm thick electroplated zinc coating (dark band). Note the dark oblong imperfection just below the surface of the pin.

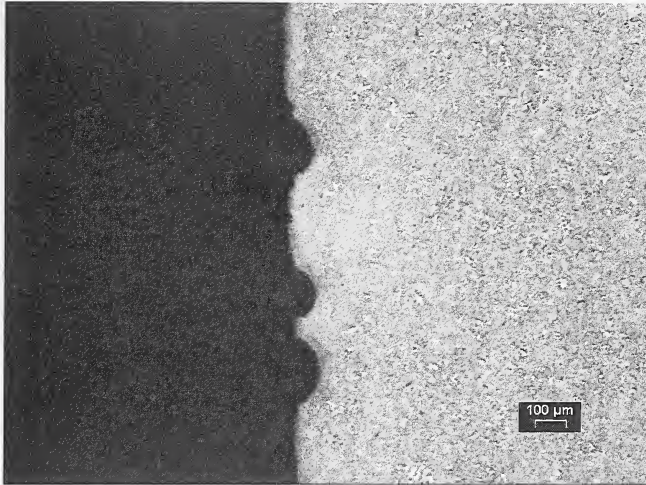
Figure 11: In some regions, the new pins had pits, shown here in the cross section. These particular flaws were found adjacent to the radius at the head of the pin.

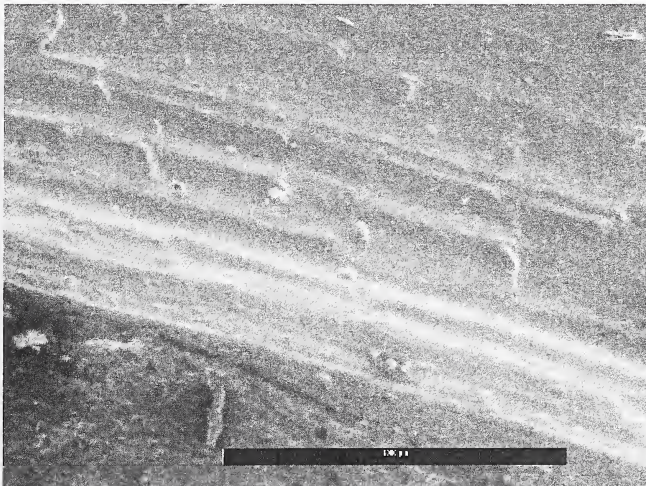
The machined surfaces of the new pins also have circumferential tool marks along the length of the shank and in the head-to-shank radius, as seen in figure 12.

Figure 12: Here, more of the outside surface of the failed pin is visible, in the region where the fatigue cracking initiated. The grooves from the machining shown here were typical of those found on the sample. The length of the scale bar is 1000 μm.

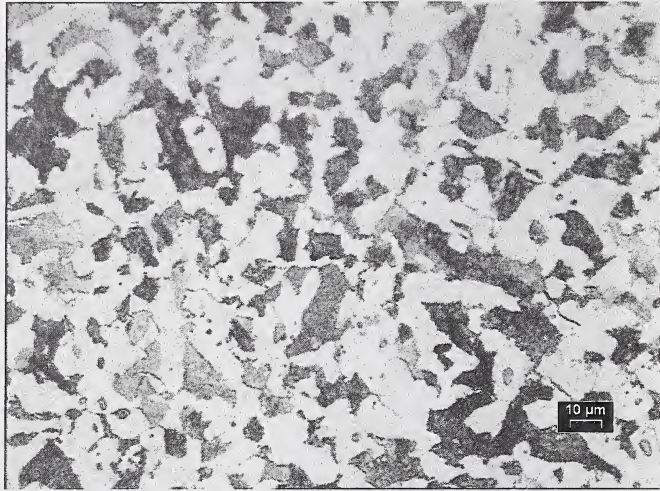
Figure 13: The steel used for the old pins was a plain carbon steel (AISI 1030). The microstructure of the steel was found to be a mixture of ferrite and pearlite, as might be expected. The grain size was not quantified, but as shown here, it is reasonably small (10 to 20 μm) and was found to be uniform across the pin we examined.

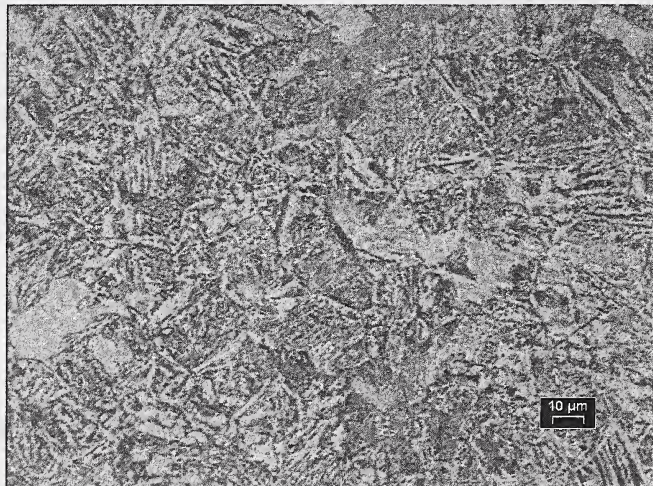
The new and old pins have different microstructures, as shown in figures 13 and 14. The old steel has a mixture of equiaxed ferrite grains and regions of pearlite, which is indicative of plain carbon steel with good ductility. The new steel has a coarse structure, as shown in figures 15 and 16. It is interpreted to contain plates of ferrite and upper bainite, which is not a microstructure that is associated with good fracture toughness [4]. This structure is consistent with that which would be expected for air-cooling of the 4140 alloy from the forging temperature, which is how the pins were made [1].

Figure 14: The steel used for the new pins, seen here, is an alloy steel (AISI 4140). The microstructure appears to be a mixture of ferrite plates (light) and upper bainite with some pearlite (dark regions).

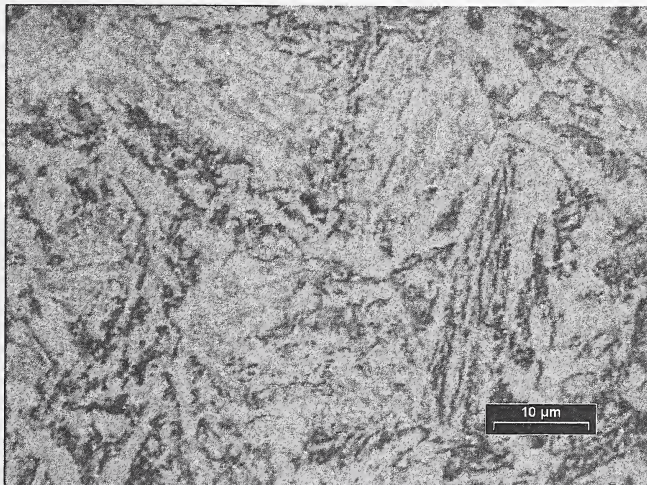
Figure 15: The AISI 4140 steel, at higher magnification than in figure 14, shows the microstructural constituent more clearly. In many regions (not necessarily here) the carbide phase in the bainite (and pearlite) appears to be spheroidized.

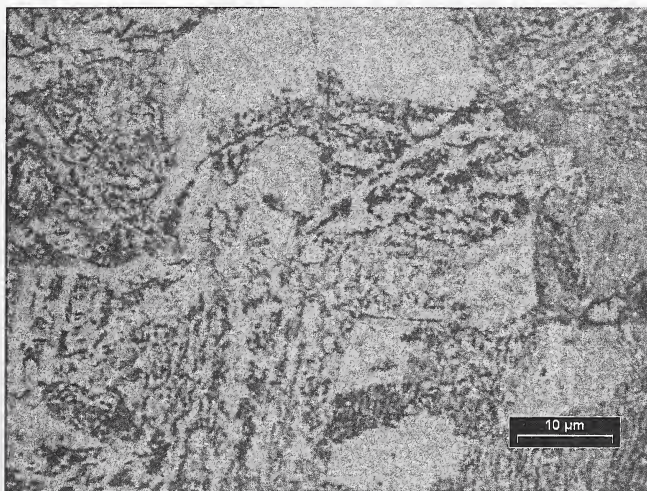
Figure 16: Microstructure of the AISI 4140 steel showing features similar to those shown in figure 15, but from a different location in the cross section of the sample. The microstructure was quite uniform throughout the cross section of the pin we examined.

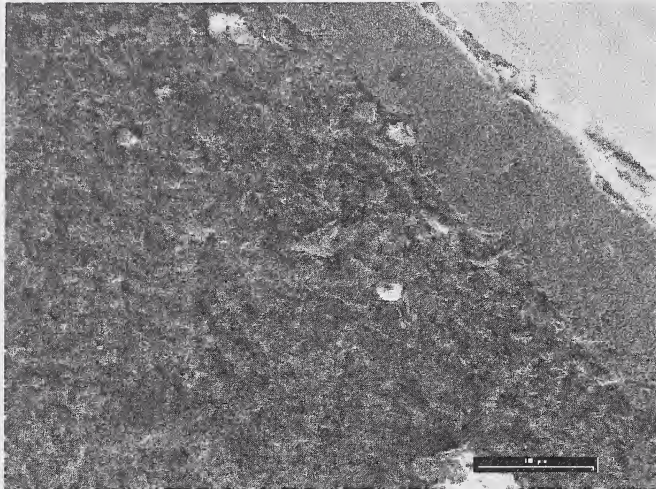
Figures 17 to 21 relate the microstructure of the failed pin to the fracture surface. The fracture features observed on the surface of the fatigue crack indicate a somewhat tortuous crack path, with details that reflect the complex arrangement of the plate-like phase constituents in the steel. These details are most clearly shown in figures 18 and 19. Grain orientation and the microstructural constituents of the steel affect the growth of the fatigue crack. Some corrosion products are present on the surface of the fatigue crack, as expected, due to slow crack growth and exposure to environment and/or failure to protect the fracture surface following failure. In figures 20 and 21, the fracture surface features of the overload region of the pin are shown. Quasi-cleavage features that are indicative of brittle fracture in steel dominate these regions, which is somewhat surprising. One would expect to observe a more ductile fracture mode for 4140 steel. However, since this pin apparently consists of upper bainite rather than tempered martensite, a brittle fracture is conceivable. Typically, a 4140 steel forging would be specified to have a quench-and-temper heat treatment rather than to be air-cooled. This would be expected to increase the toughness for a given level of strength.

Figure 17: Starting at the upper right-hand corner, the outside surface of the pin is shown, then a darker band that is likely a ridge of zinc plating near the origin of the fatigue crack (the top edge of the zinc was probably deformed following the failure), then the appearance of the fatigue-crack surface. The length of the scale bar is 100 μm .

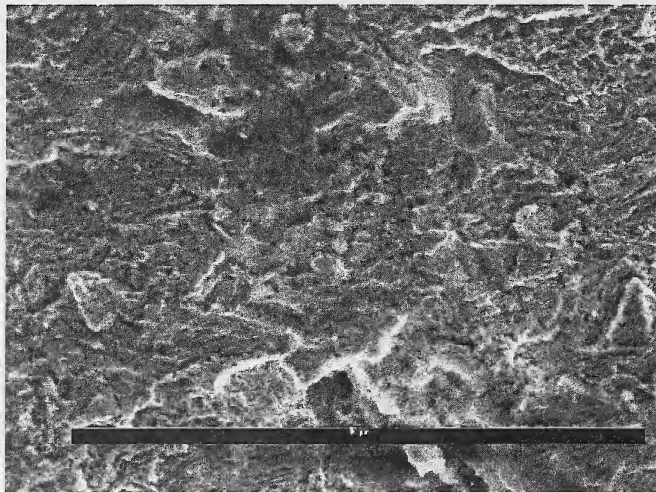
Figure 18: The surface of the fatigue crack has a complex and very fine structure, which reflects the microstructure of the steel. The length of the scale bar is 100 μm .

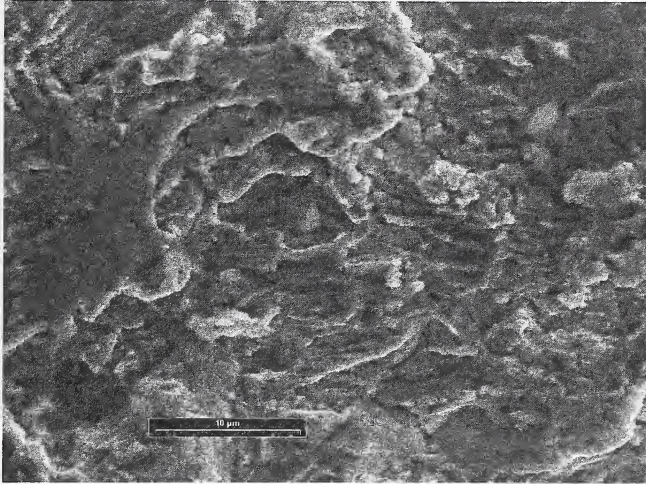
Figure 19: At slightly higher magnification, the nature of the torturous path of the fatigue-crack is even more evident. The length of the scale bar is 10 μm.

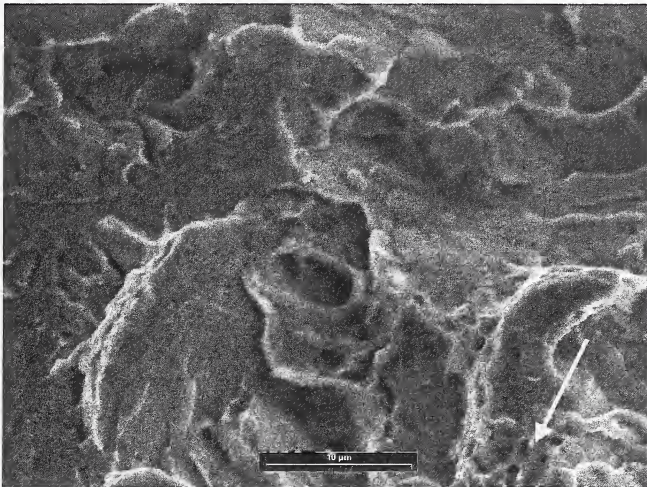
Figure 20: The overload regions of the pin failed in a brittle manner by a quasi-cleavage mechanism. The yellow arrow points to a local area of more ductile fracture and ductile dimples. The scale bar is 10 μm in length.

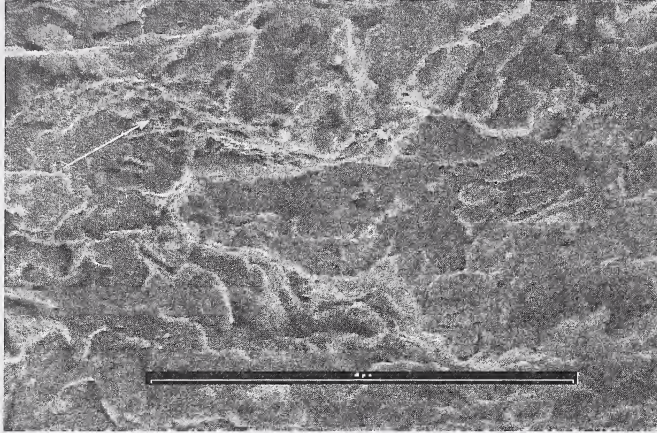
Figure 21: Another example of the classical quasi-cleavage-like appearance of the fracture surface of the pin in the overload region of the pin that failed in service. The arrow points to local ductile dimpling. The length of the scale bar is 50 μm .

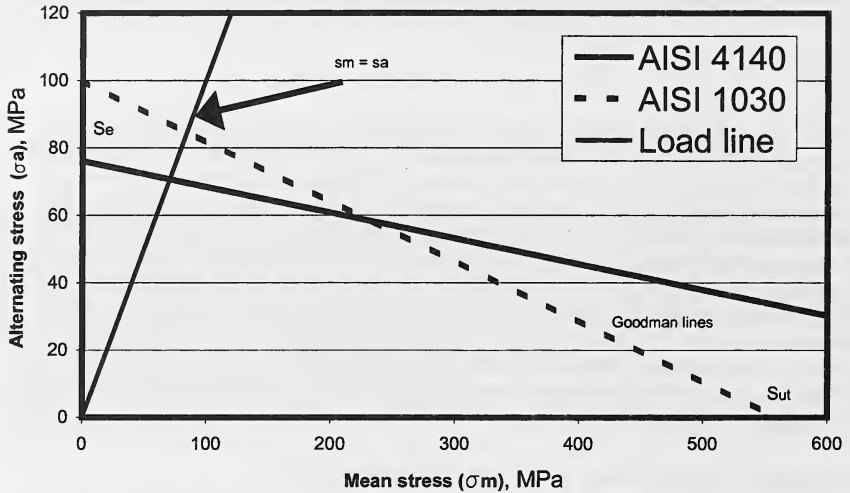
Figure 22: Goodman diagram for AISI 1030 and AISI 4140 steel pins. Arrow shows load line where alternating stress is equal to mean stress.

The two axes of the diagram are alternating (σ_a) and mean (σ_m) stresses. The Goodman line is drawn for both AISI 1030 and AISI 4140 steels. These lines intersect S_e on the σ_a axis and the S_u on the σ_m axis. The “load-line” pointed out by the arrow, assumes the condition where mean stress is equal to the alternating stress. If the plotted stress stays below the material curves, then the respective material should last for more than 10^6 cycles.

Since we have no actual loading data on the pins, we can only make an educated guess in stating that the load is alternating somewhere between a maximum point (less than ultimate load) and zero (since the pins in this application cannot be loaded in compression). This means that the alternating (σ_a) and mean stress (σ_m) will lie on the $\sigma_a = \sigma_m$ line, pointed out by the arrow in figure 22 above. The factor of safety is determined by dividing the distance from the origin to the failure line (Goodman line) by the distance from the origin to the effective stress.

For example, we suppose the nominal stress in the pin is 40 MPa (5.8 ksi) and this nominal stress is multiplied by the K_f of 2.13 for the AISI 4140 steel pin with a sharp radius. The effective stress would be 85 MPa (12.3 ksi). This lies clearly above the failure line of the Goodman diagram, and would result in a short lifetime for the pin. If we use the same stress for the AISI 1030 steel, with a K_f of 1.73, we would have an effective stress of 69 MPa (10.0 ksi). This lies below the failure line for the AISI 1030 steel pin and would result in a long life for the pin. The factors of safety for the 1030 and 4140 pins are 1.23 and 0.82, respectively. This example demonstrates the advantage of the well machined 1030 steel over the poorly machined 4140 steel, if we assume that the wind load goes from zero to a maximum level.
